The assessment of the effect of various surface treatments on the shear bond strength of three different intraoral ceramic repair methods

Premkumari S. Sharma

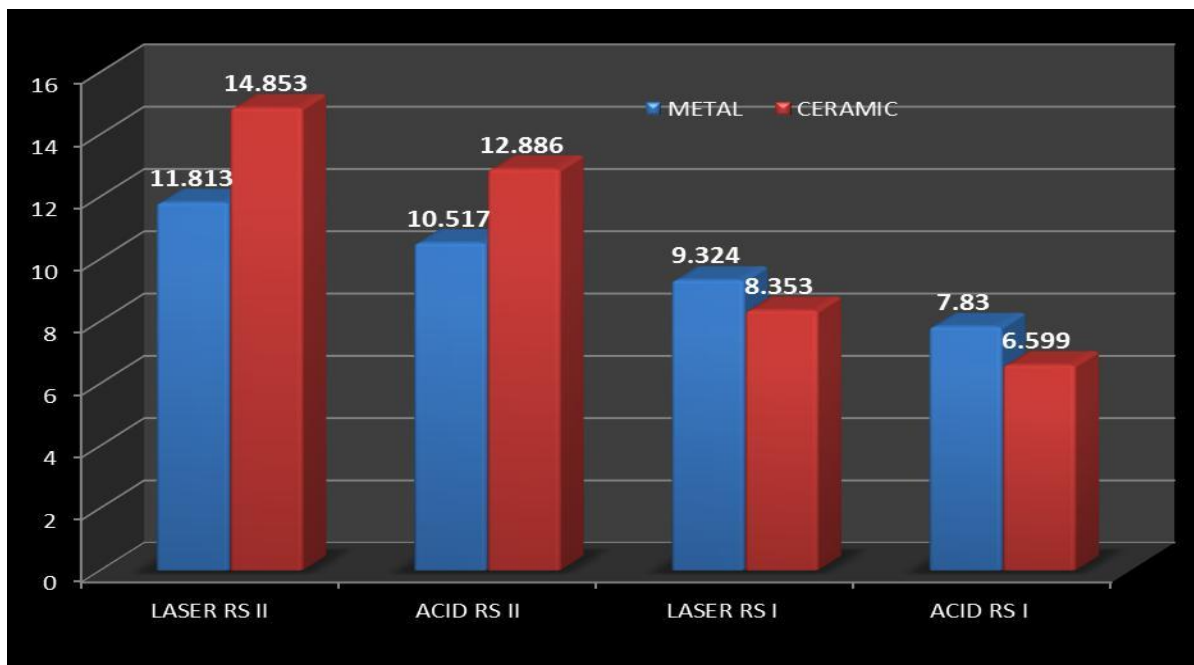
Graph 1: Comparison of mean shear bond strength values among the two repair systems for both acid etched and laser surface treated surface specimens under both ceramic and metal substrates

Multiple comparisons between the two repair systems with two different surface treatments under ceramic and metal substrates in table 5 showed highly significant values. Under the laser surface treatment repair system II showed higher shear bond strength values for ceramic substrates while for repair system I higher shear bond strength values were obtained for metal substrates. Under the acid surface treatment repair system II showed higher shear bond strength values for ceramic substrates while for repair system I higher shear bond strength values were obtained for metal substrate (Graph 1).

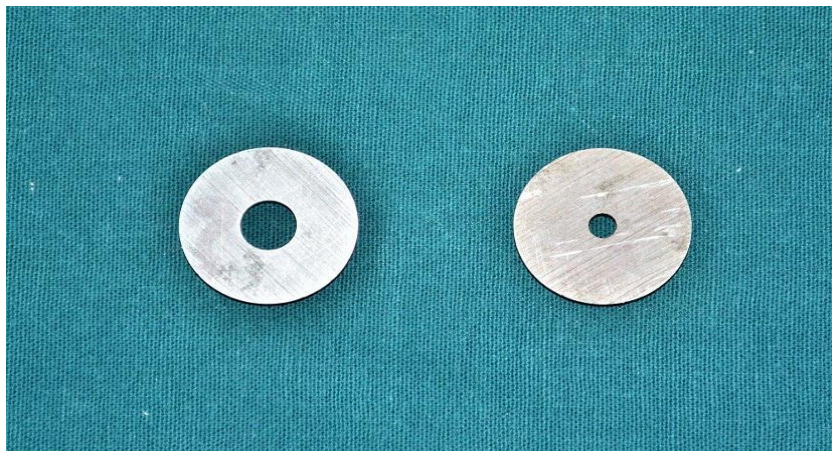
Figure 3: Customized matrix for specimen fabrication

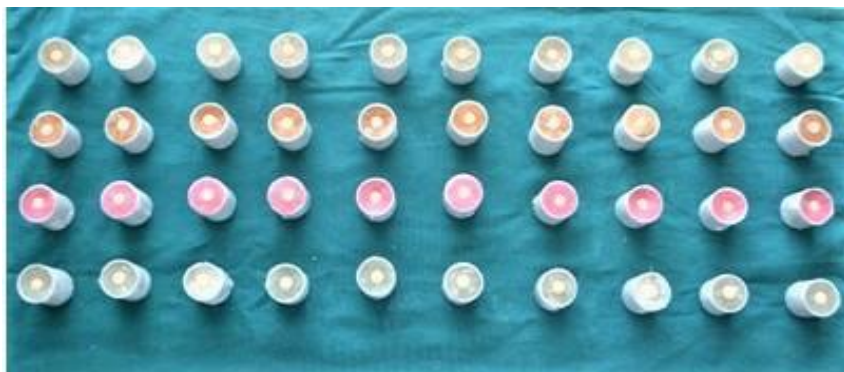
Figure 6: Ceramic substrates embedded in acrylic

embedded in a polyvinyl chloride (PVC) ring (25mm diameter and 27 mm height) using polymethyl methacrylate resin in such a way that the flat surface of the metal and ceramic discs were left flush with acrylic resin, leaving the disc at a higher level to facilitate shear bond testing [6]. All specimen bonding surfaces were smoothed with silicon carbide papers (120-, 220-, and 320-grit) (Figure 6 and Figure 7).

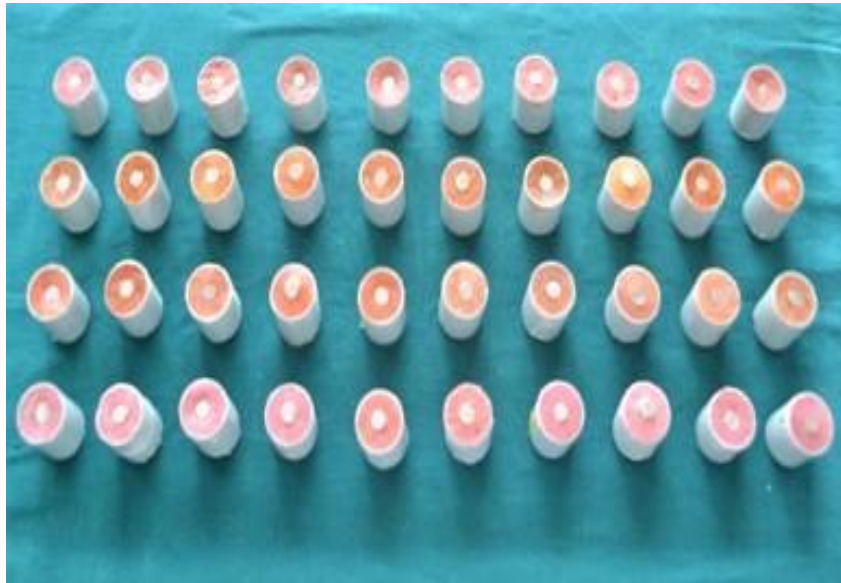
Figure 7: Metal substrates embedded in acrylic

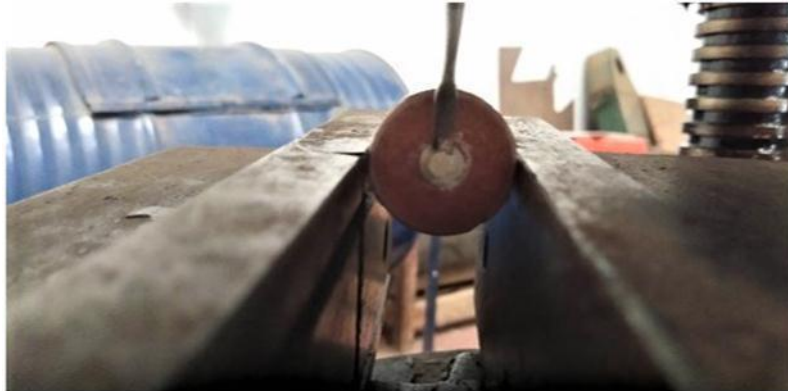
Figure 8: Shear bond strength test

All specimens were stored in distilled water for 24 hours before thermal cycling, which occurred between 5 °C and 55 °C for 300 cycles with a 30-second dwell time. After thermal cycling, the specimens were stored in distilled water for an additional 8 days before being subjected to a shear load using a testing machine with a 10-kN load cell and a 0.5-mm/min crosshead speed. A chisel apparatus was used to direct a parallel shearing force as close as possible to the resin/substrate interface (Figure 8). The shear debonding forces were recorded in N. The failure loads (N) were divided by the bonding areas (mm²), and then the shear debonding forces were converted into MPa. The shear bond strength values were recorded in megapascals (MPa).
